Page 1 of 4 *Resource Name or #: K55

***P11. Report Citation:** J.W. Snyder, R. Reno, and C.D. Zeier. 2006. Historical Resources Evaluation Report:

Kings Beach Commercial Core Improvement Project. P.S. Preservation Services and Geoarch Sciences, Inc. Minden.

Page 1 of 3 *Resource Name or #: K56

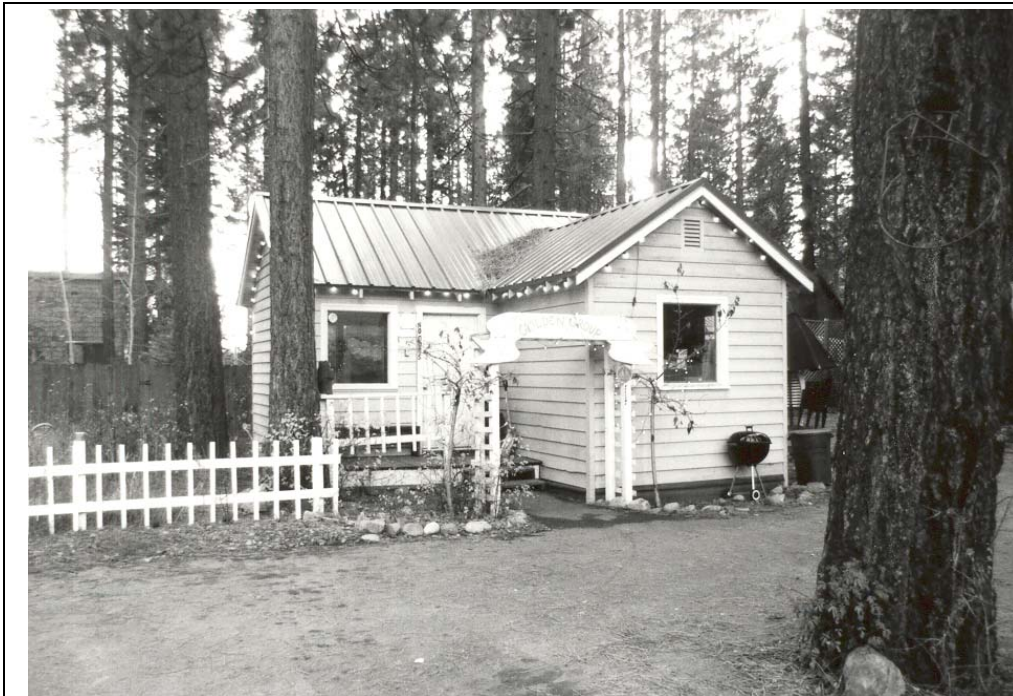
P5b. Description of Photo:
090-134-030, Building A, View SW.
Roll KBB4, Fr. 15. 11-14-02, 3:50 PM.

***P3a. Description:** This property includes two small businesses, in what appear to have originally been residential buildings, and an outbuilding. They are set on a lot that is mostly paved parking but supports some native trees. Building A is a small one-story L-plan wood frame house. It has a cross-gable roof with exposed rafters and open eaves, clad with standing seam metal. The building is sheathed with wood lap siding. Original windows are wood 1/1 double-hung, but both windows on the front façade have been replaced with fixed single light windows. The door is clad with wood V-rustic siding. The house has a recent (c.1990s) picket fence and trellis entry bearing the business sign. (continued)

Building A has been modified with windows and roof cladding (c. 1990s).

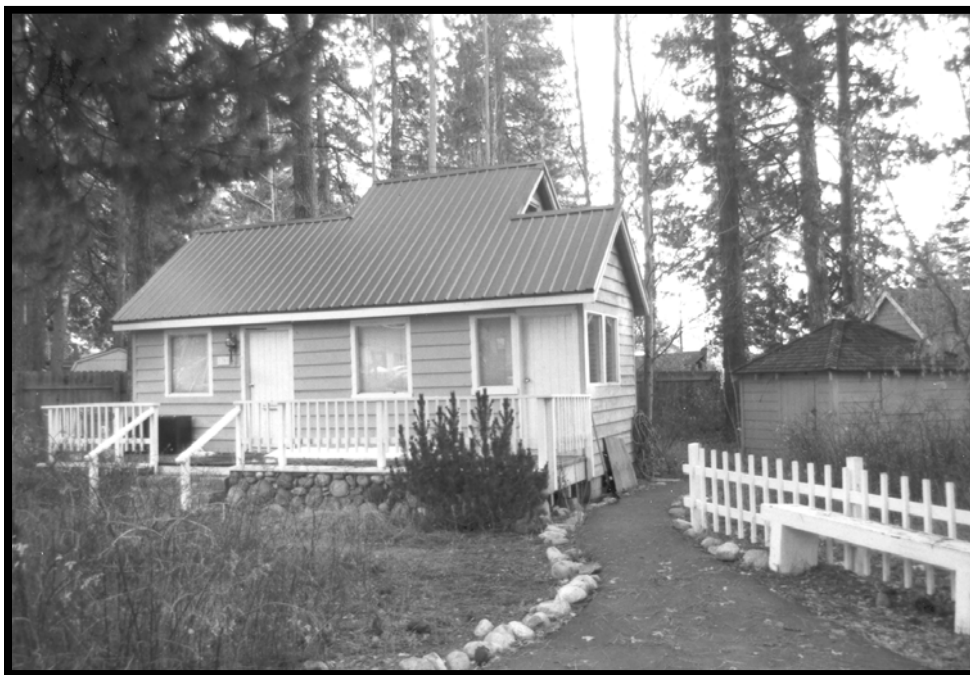
090-134-030, Building B, View E.
Roll KBB4, Fr.14. 11-14-02, 3:50 PM.

Building B has been modified with recent (c.1990s) windows and roof cladding.

Building B is a 1½-story rectangular plan wood frame house. It has a side gable roof with open eaves and fascia, clad with standing seam metal roofing. Walls are sheathed with wood lap siding. All visible windows are fixed single light. The door is clad with wood V-rustic siding. An open porch with simple railings and cobble foundation extends the width of the main facade

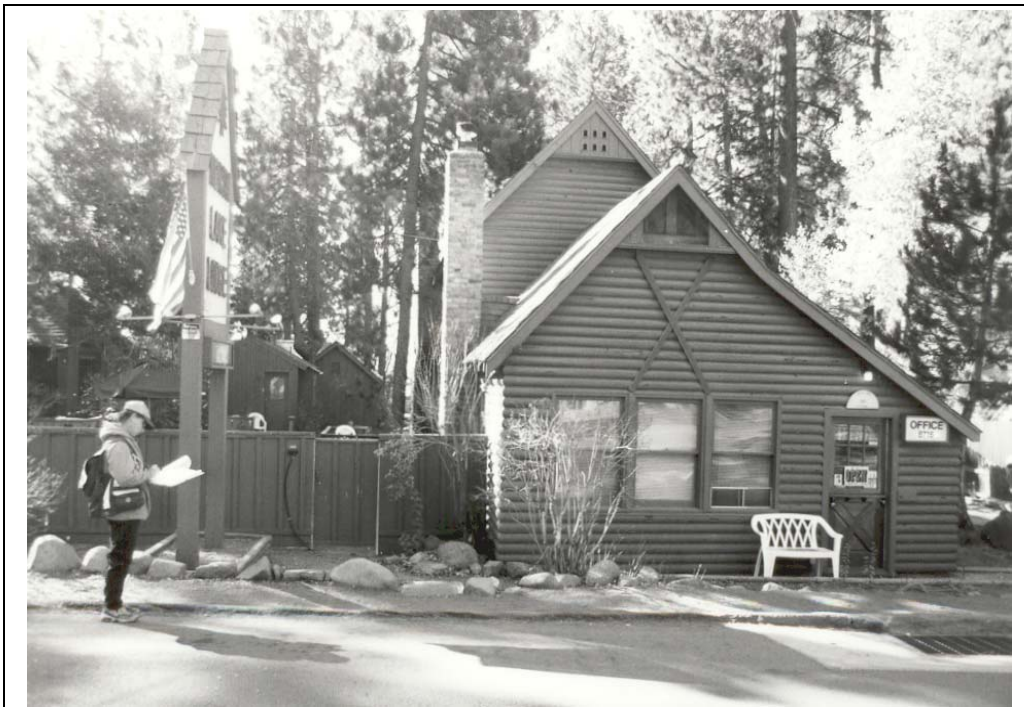
090-142-001, View South.

***P3a. Description:** This property is presently part of the North Lake Lodge, which includes the lots to the east and south. Portions of the lots not used for parking support native trees. The building is a two-story rectangular plan wood frame motel. It has a gable roof with open eaves and exposed rafters, clad with composition shingles. Walls are clad with stained log cabin siding. Windows are wood 1/1 double-hung and wood sliding. Four windows have been replaced with metal sliders. Doors are recent X-panel with lights. There appear to have been several additions, but all appear historic. The building has two brick fireplaces, of which the northern one appears recent. The building has a large open porch. Recent lattice has been added to the railings.

Additions appear to be c.1950s. Recent (c.1990s) modifications include door, windows, fireplace, and porch rails.

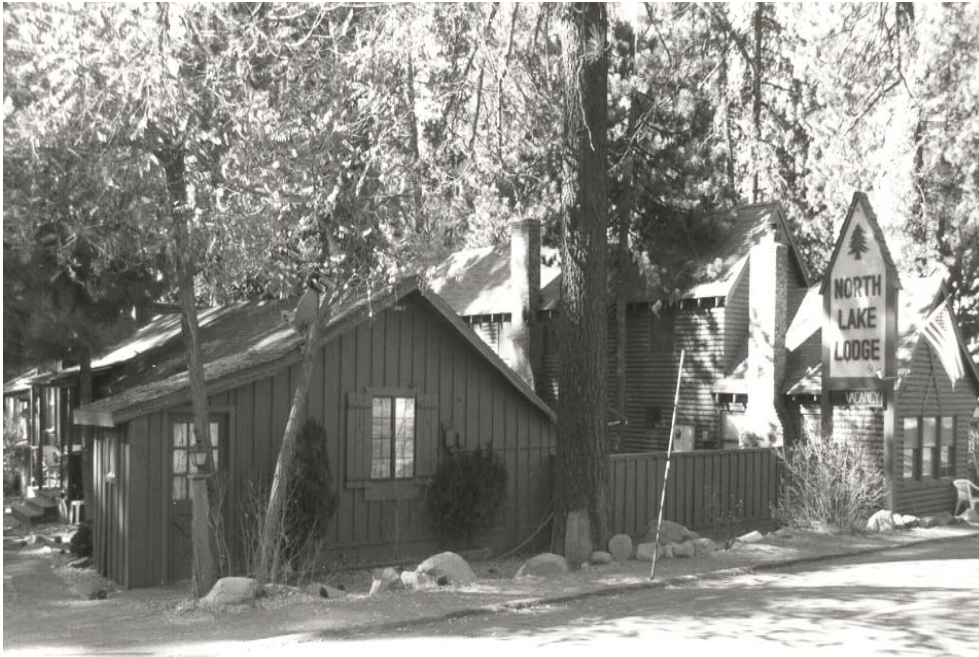
P5b. Description of Photo:
090-142-002, Building A, View SW.
Roll KBB1, Fr.8. 10-30-02, 10:05 AM.

Building A is a one-story building with multiple rental units. It has a complex plan due to several additions linking what appear to have been several previously separate buildings. It has a cross-gable roof with open eaves and fascia, clad with composition shingles. The walls are sheathed with stained board and batten siding except for plywood T1-11 on the south end. Windows include wood casement with various numbers of lights, metals sliders and metal 1/1 double-hung. Doors include V-rustic, panel, and flush with two lights. Recent (c. 1990s) doors are X-panel with lights. A porch has been added. (continued)

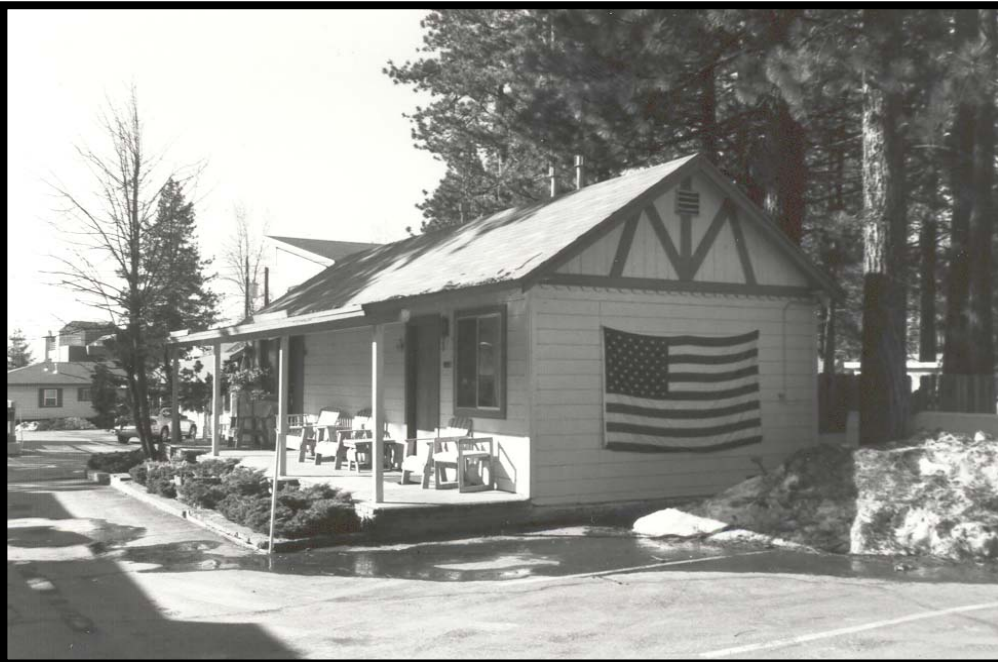
Building B, View SW.

Building B is a one-story rectangular plan wood frame building. It has a side gable roof with open eaves and gable ends partly covered by a recent fascia. A recent porch supported by simple posts extends along the entire east side of the building. Walls are sheathed with painted wood V-rustic siding. Recent contrasting trusswork trim has been added to the gable end. Windows are aluminum sliders and the doors are recent flush. A small shed has been added to the south end of the building.

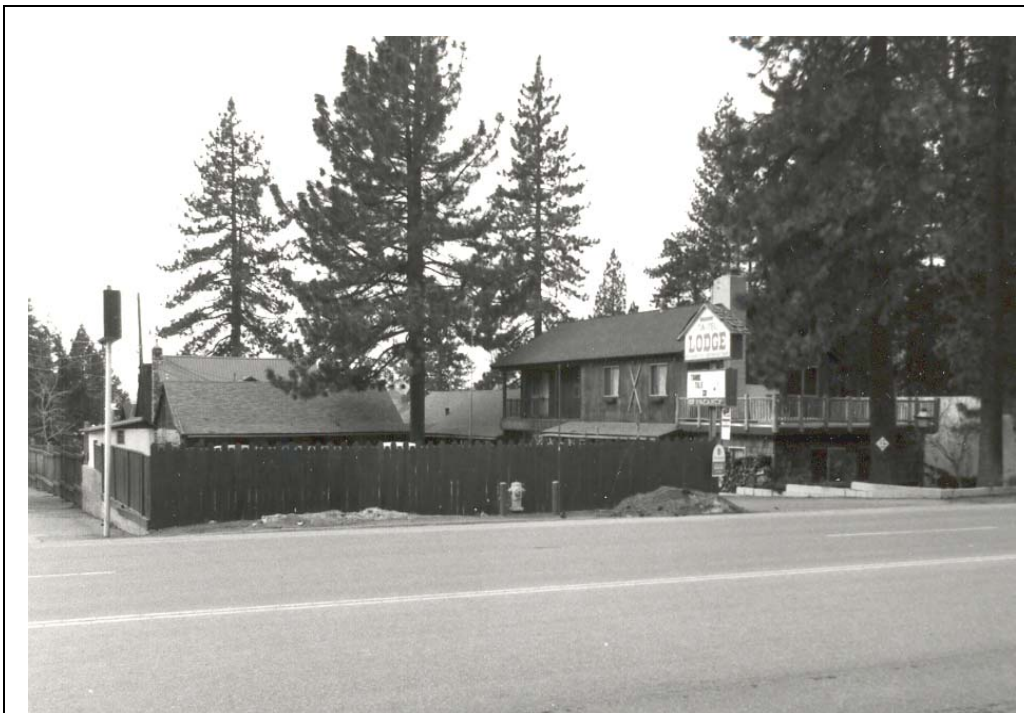
090-142-026, View SW.

***P3a. Description:** This building is a one and two-story L-plan cinder block motel. As originally built, it was one-story with all walls made of cinder blocks with rounded corners. It has a gable roof with open eaves and exposed rafters, clad with composition shingles. Gable ends are clad with stained wood V-rustic siding. Original windows are metal casement, but many have been replaced with aluminum sliders. Doors are flush. The entire second story is a gabled addition, clad with plywood T1-11 siding. It has aluminum sliding windows and patio doors and a cinder block chimney. At the north end of the building is a second addition. This is one-story with a flat roof that doubles as a deck. It has milled shingle siding, aluminum sliders, and peeled log railings. A third addition is a shed-roofed enclosed entry porch. The original porch above entries all along the rear of the building is supported by pillars made of rounded-corner cinder blocks. There is a concrete pool at the northeast corner of the property. Cinderblock and cobble retaining walls and planters have been added. A few native trees survive at the rear of the lot. The sign is recent (c.1990s).

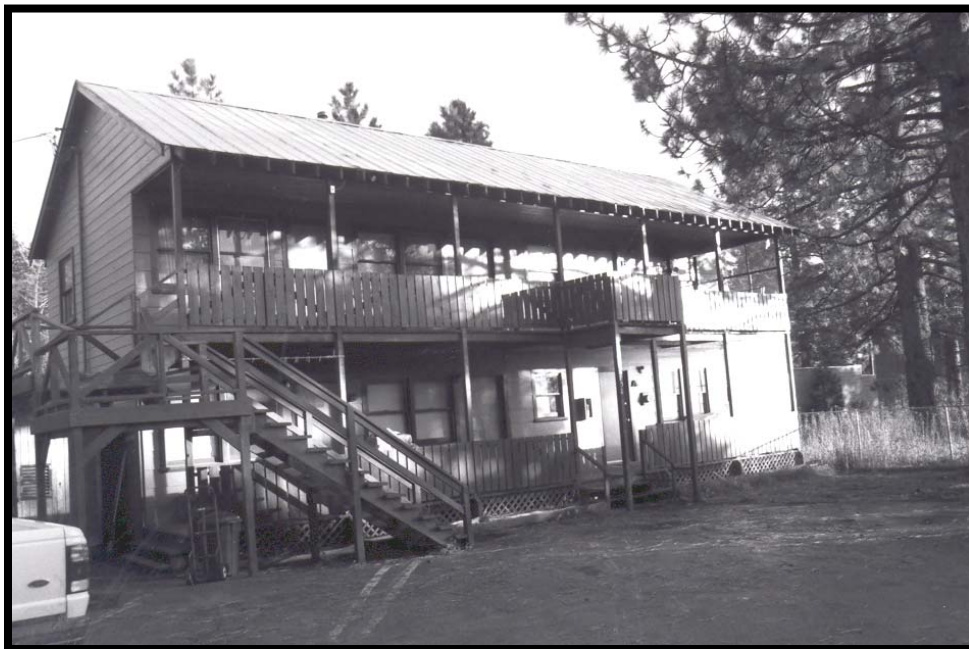
090-142-007 Building B, View SE.
Roll KBB4, Fr.16. 11-14-02, 3:55 PM.

Building B is a two-story rectangular plan wood frame apartment building. It has a side-gable roof with exposed rafters and open eaves, clad with recent aluminum panels. The building has a full-length covered porch supported by simple posts with vertical board railing. Walls are clad with painted wood lap and V-rustic siding. Windows are wood 1/1 double-hung, some of which are covered with metal storm windows or temporary plastic sheets.

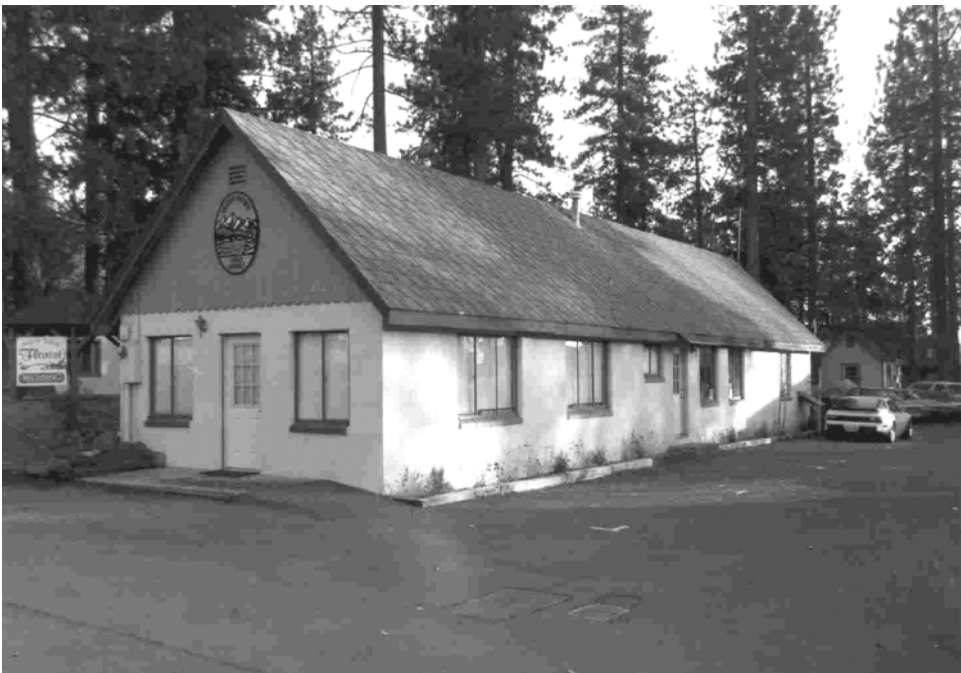
090-221-018, View SE.

***P3a. Description:** This building is a one-story rectangular commercial structure made of rounded-corner cinder block. It has a gable roof with open eaves and fascia clad with locking composition shingles over an older layer of standard tab composition shingles. Walls are unsheathed block except for the gable ends, which are of painted wood V-rustic siding. Windows are steel 2 and 3 light casement. The door is panel with lights. A metal exterior chimney has been added. The entire lot is paved.

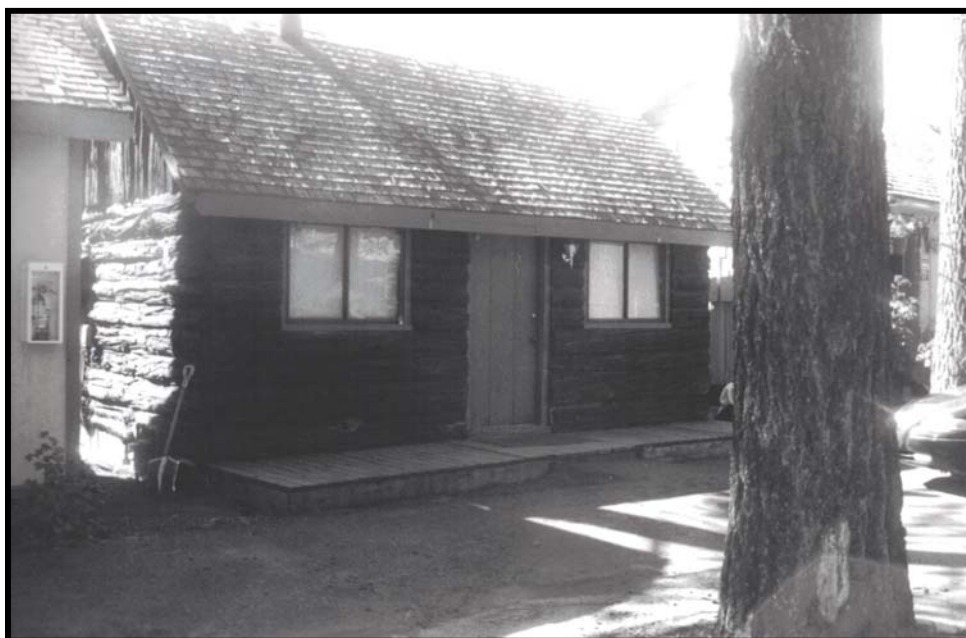
Building B (Front), View NW, KBB13, Fr. 24,

Building B is a one-story wood frame house matching the description for the north half of Building A except that the windows have been replaced with metal sliders.
